Coastal Geologic and Engineering History of Presque Isle Peninsula, Pennsylvania

*by Richard J. Gorecki
U.S. Army Engineer District, Buffalo*

*Joan Pope
Coastal Engineering Research Center*

Final report

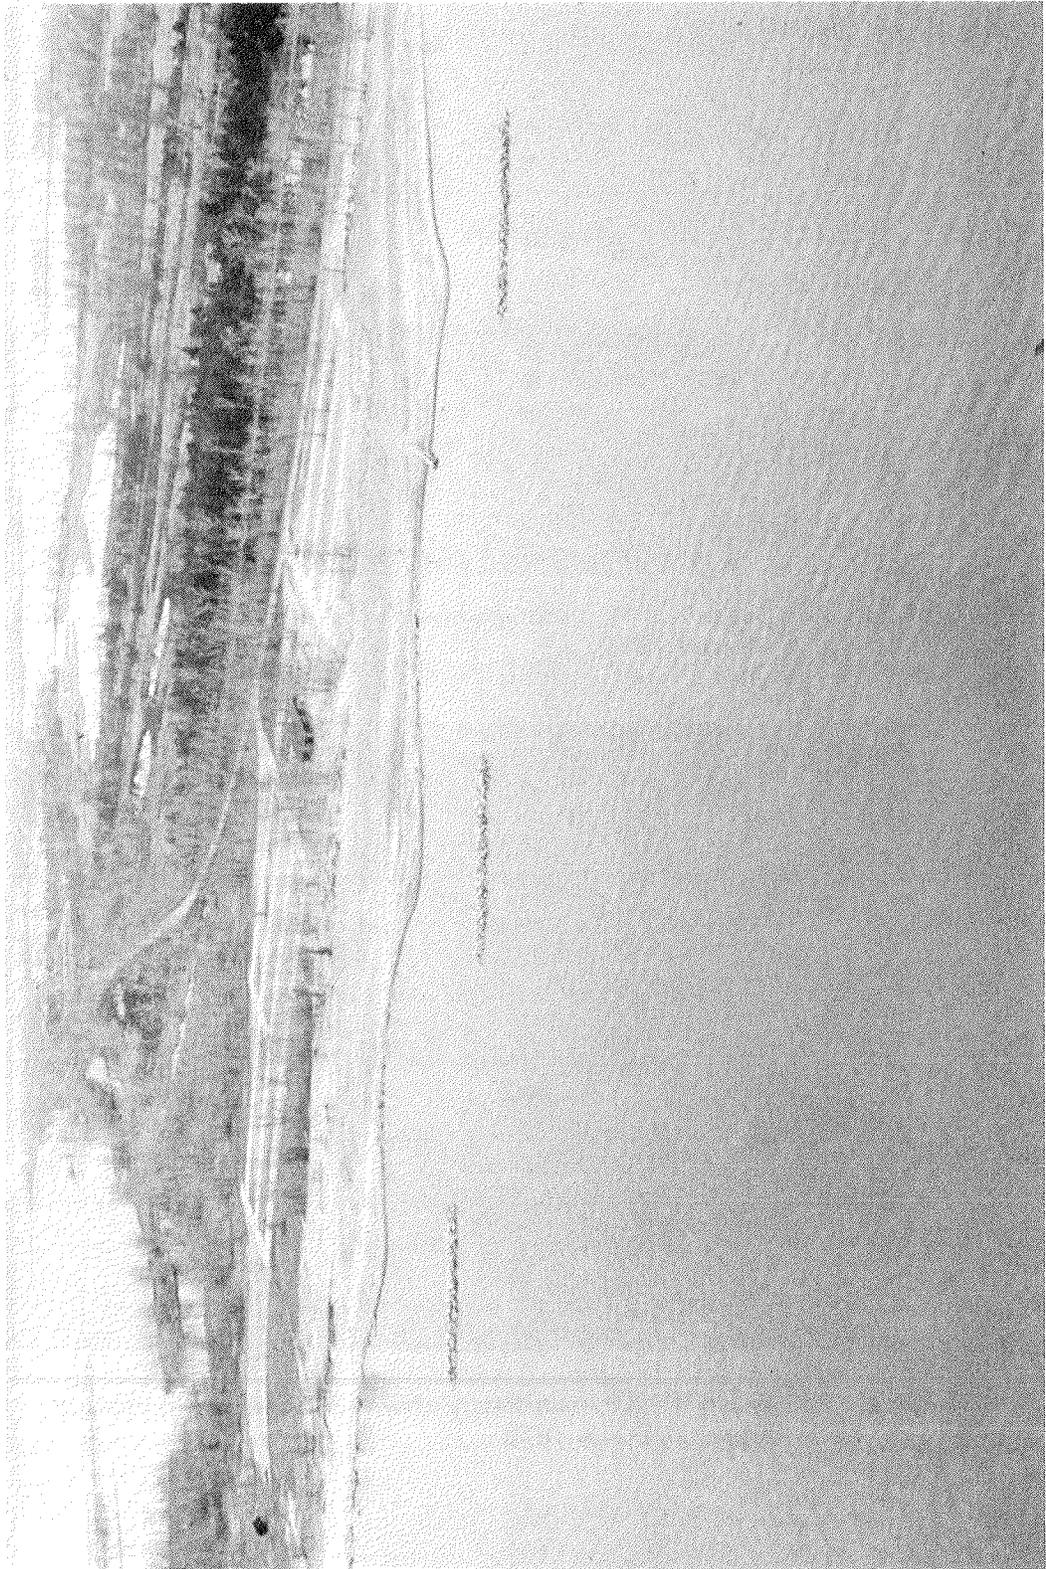
Figure 21. Prototype breakwater project after construction

breakwaters while being effective in holding a beach. Figure 21 shows the project after construction.

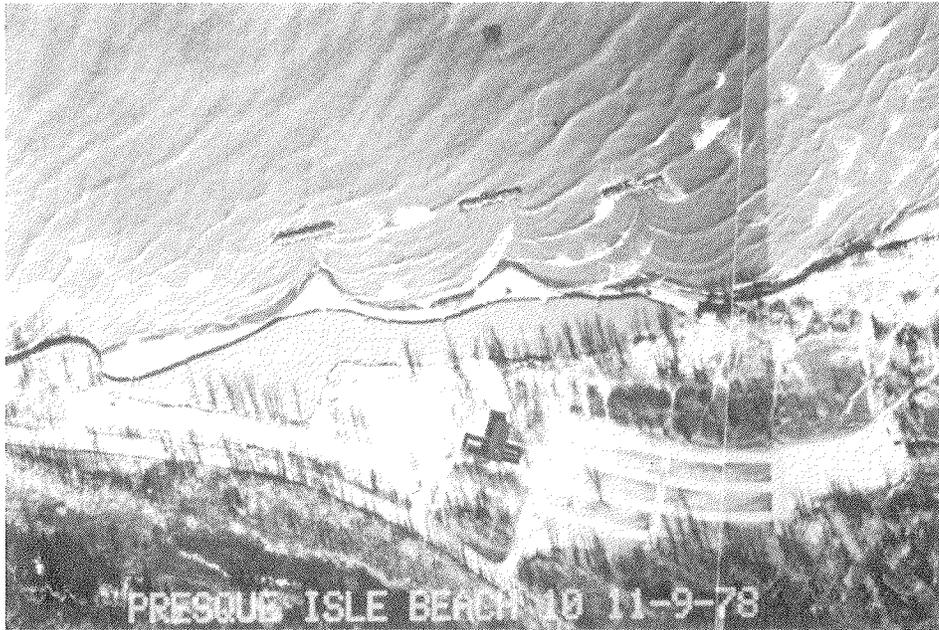
Figure 24. Beach No. 10, 9 November 1978

- a. By November 1978 (Figure 24), distinct salients were present behind the western and center breakwaters.
- b. On 6 April 1979, the project was subjected to a severe storm which may have exceeded the design event (design lake stage = 575.3 ft IGLD or +6.7 ft LWD and design wave = 7.0 ft) when winds gusting to 62 knots caused waves estimated by state park personnel to be 8 to 10 ft. A field inspection after the storm showed that there had been major changes along other portions of the peninsula shoreline; however, the breakwaters performed as designed with only slight movement of the stones, and salients still existed behind each structure as shown in Figure 25.
- c. In November 1979 (Figure 26), tombolos existed behind the western and center breakwaters and one had almost formed behind the eastern structure.

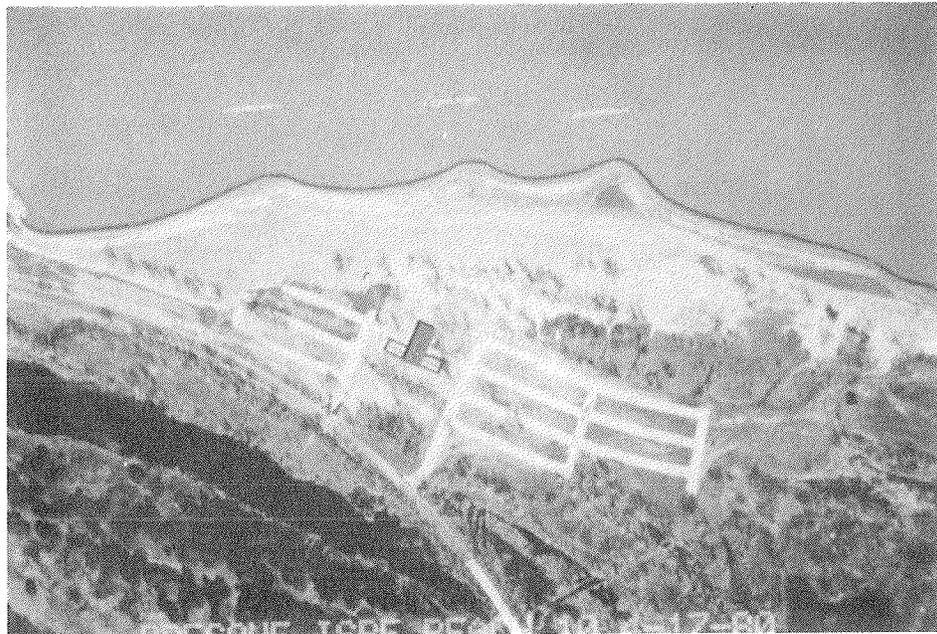
Figure 27. Beach No. 10, 17 April 1980

- d. Salients were still present in April 1980 (Figure 27). The 1980 fall photography (Figure 28) showed that there was not much change in the beach since the spring.

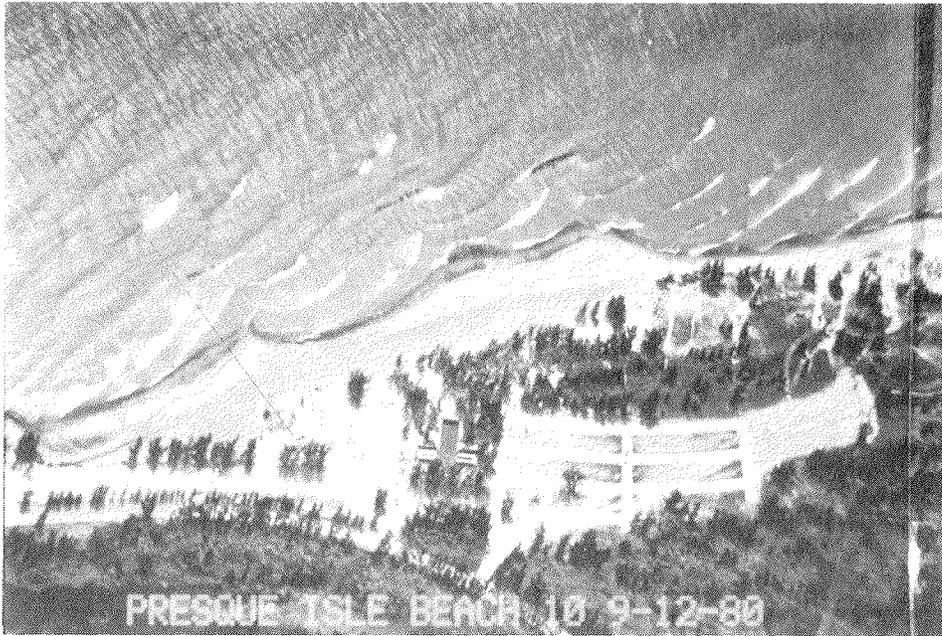
Figure 28. Beach No. 10, 12 September 1980

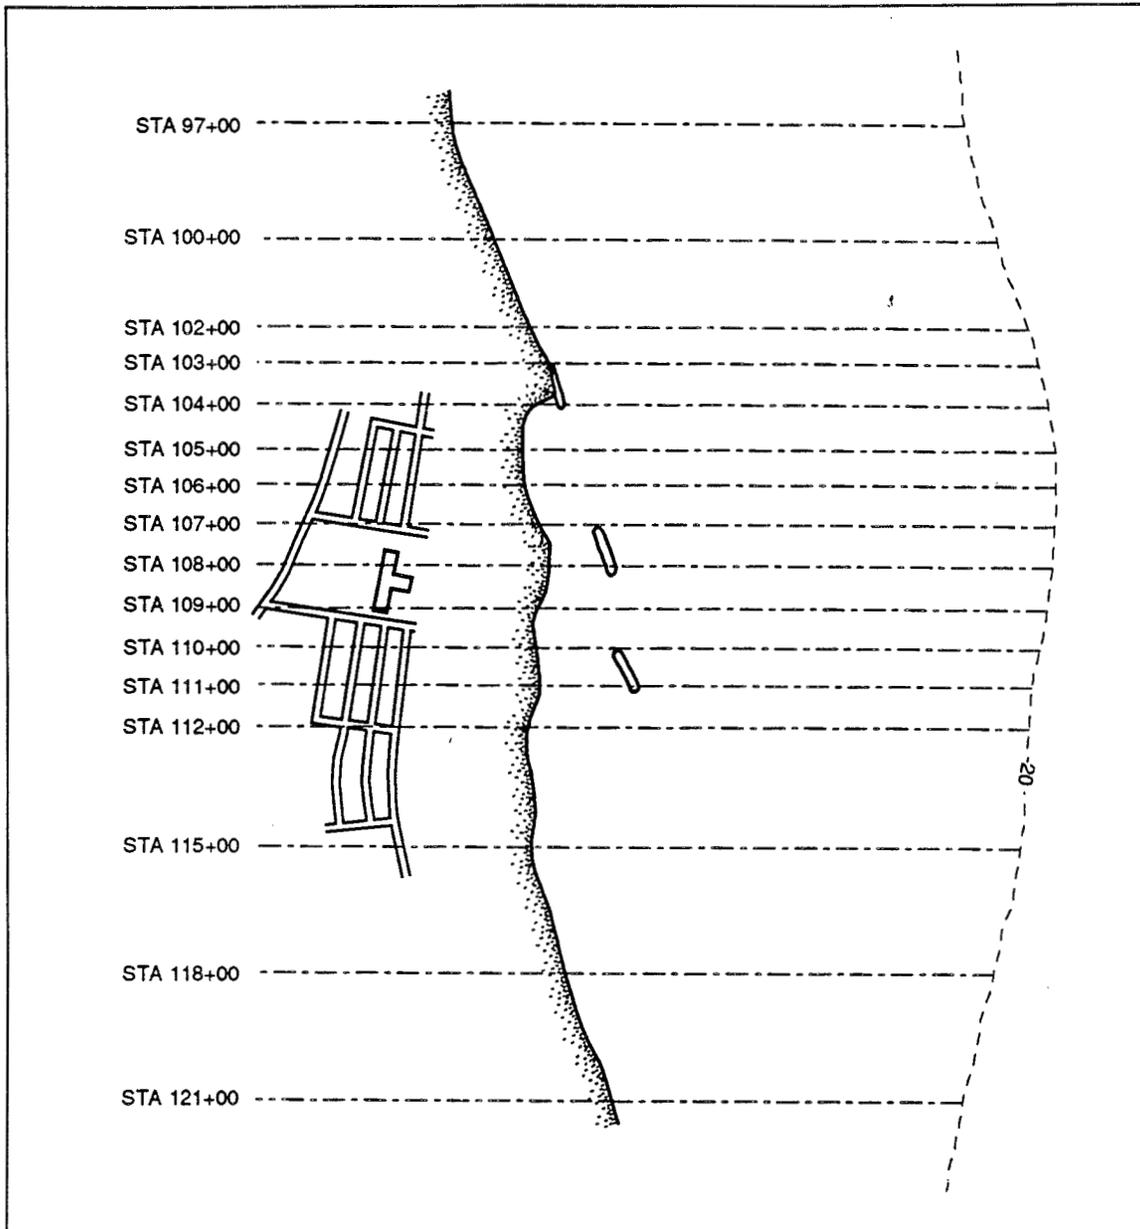
Figure 36. Survey lines established for Beach No. 10 monitoring program (modified from Gorecki (1985))

A survey plan (Figure 36) consisting of 16 profile lines was established between Stations 97+00 and 121+00. Each profile line extended from the top of the parking lot or dune through the beach area and offshore to a depth of 20 ft below LWD. A total of 13 surveys were completed. The data for each profile line from the current survey was plotted for comparison with the

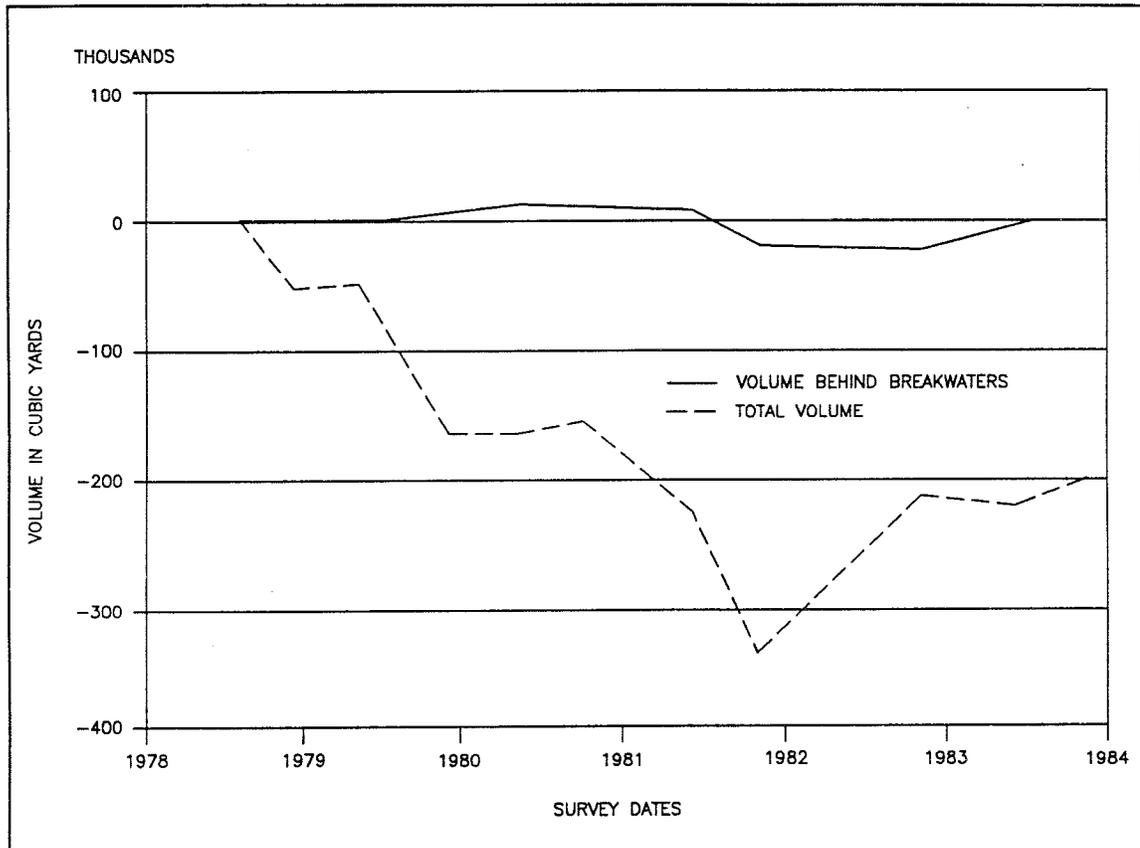
Figure 37. Volume changes measured at Beach No. 10, 1978 through 1984 (modified from Gorecki (1985))

The net results, as shown in Tables A1 and A2, indicated that during the period from July 1978 through October 1981 there were extensive losses in the offshore zones in Area "B," while there was a tendency towards accretion in the lee of the breakwaters (Area "A"). During the period from October 1981 through October 1983, a reversal was observed and accretion occurred in the offshore zones of Area "B" and losses occurred in the lee of the breakwaters in Area "A." These variations are illustrated in Figure 37.

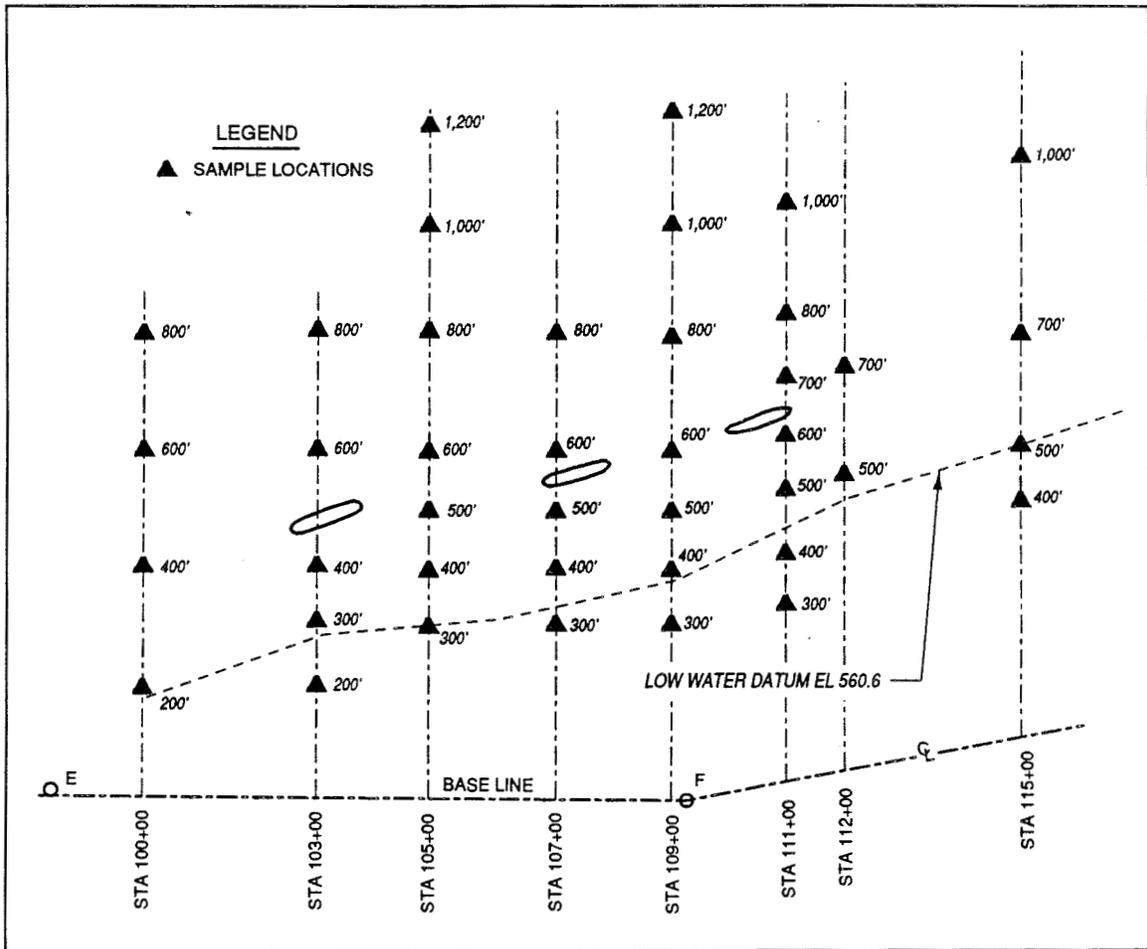
Figure 38. Sediment sampling plan established for Beach No. 10 monitoring program (modified from Gorecki (1985))

A sediment sample was collected at each of 41 locations during each of the six fall surveys (Figure 38). A gradation analysis was performed on each sample, and the results are presented in Tables B1 through B8. The results of the gradation analyses were evaluated to determine the grain size distribution in the vicinity of the breakwaters. Generally, the sampling has shown the usual progression from coarse sand near the water's edge to fine sand at the 20-ft depth. Coarser material collected lakeward of the middle and east breakwaters during the initial sampling is thought to have occurred because of dredging operations for the breakwater foundations. As documented through successive samplings, the coarse pocket was gradually reduced in area and by November 1981 had entirely disappeared. Hence, fine gravel to coarse sand was found between the water's edge and the breakwaters, and fine sand was found lakeward of the breakwaters.

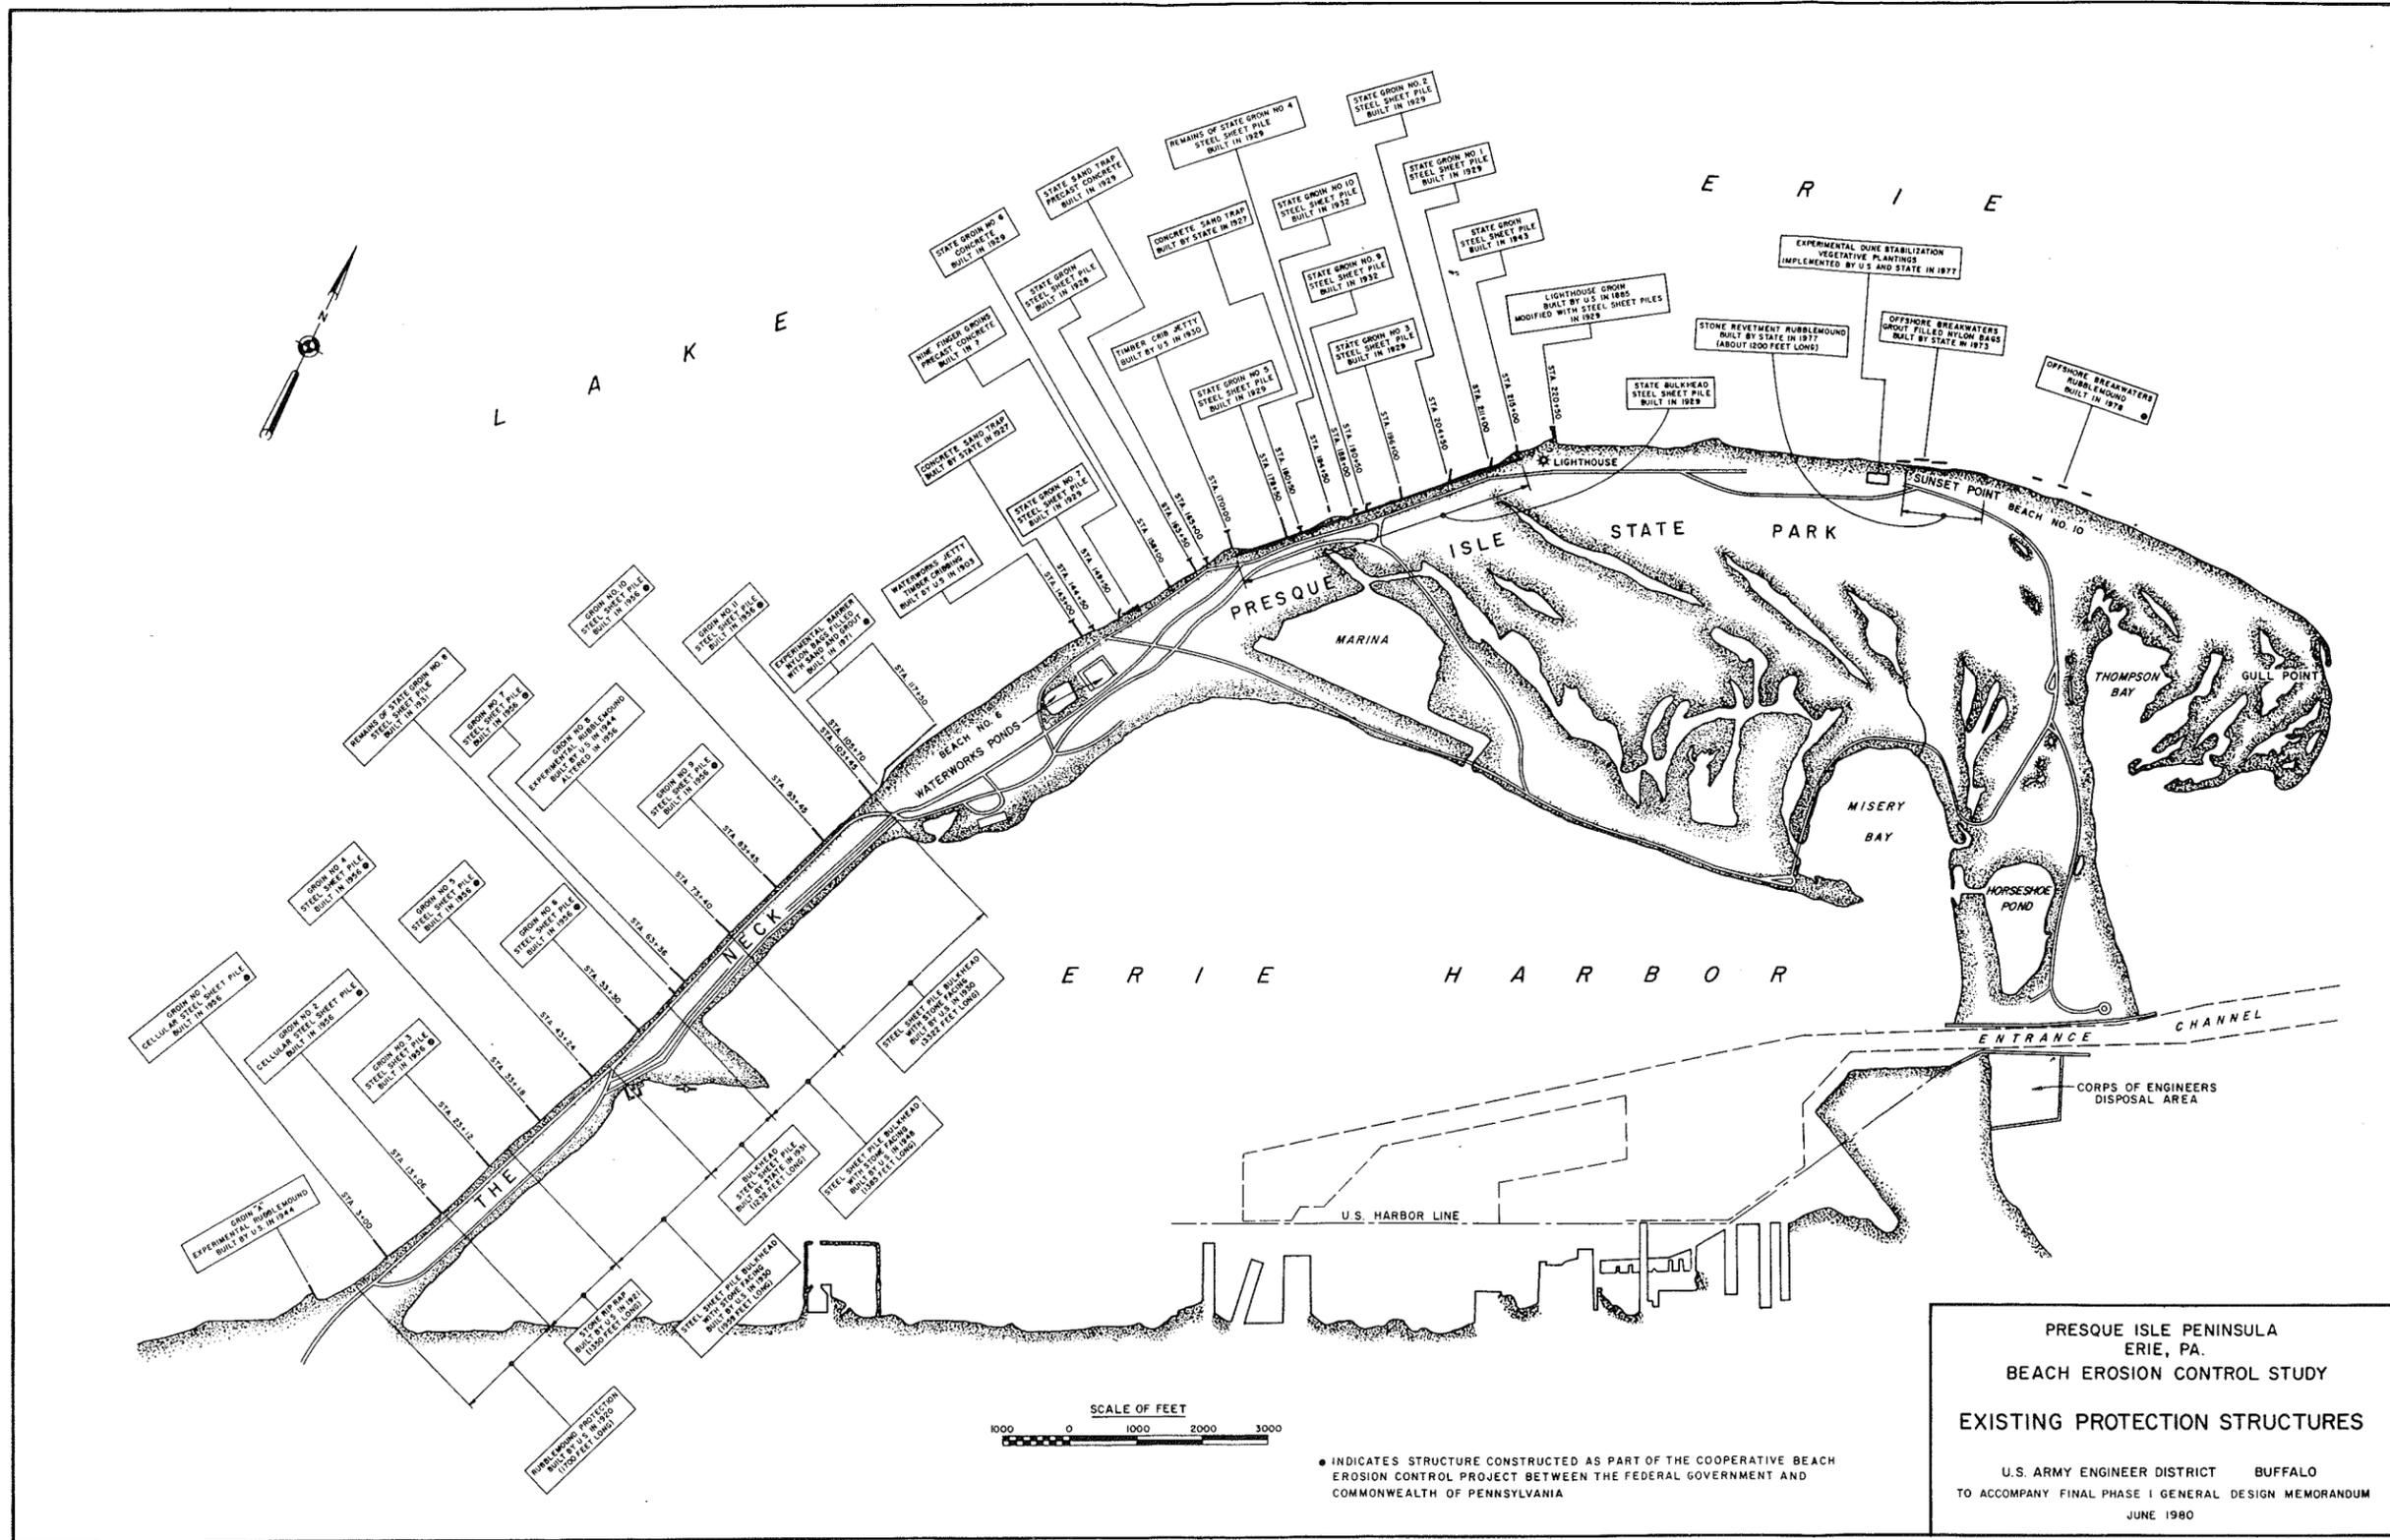
PLATE 5

Figure 39. Shore protection structures existing at Presque Isle prior to breakwater construction (USAED, Buffalo 1980)

In 1956, the Federal Government, in cooperation with the Commonwealth of Pennsylvania, completed an erosion control project consisting of a seawall, bulkhead, and groin system along the neck of the peninsula, and restoration of the beaches by placement of sand fill. Since 1956, the project has proved to be inadequate, and sand nourishment measures were required periodically through the 1960's and early 1970's, and annually from 1975 to 1991, to protect the shore protection and erosion control structures and park facilities throughout the peninsula. Sand fill is placed each year to provide sand berms with crest elevations of 10.0 to 12.0 ft above LWD and crest widths of 60 to 75 ft at selected locations as stopgap measures. These sand nourishment measures do not represent a complete solution to the erosion problem because they fail to maintain a continuous sand berm of sufficient width and elevation to provide protection for the backshore dunes and park facilities. The annual sand nourishment costs are escalating, making the continuation of annual nourishment an increasingly expensive means of controlling beach erosion. With the completion of the breakwater project in November 1992, future annual nourishment requirements will be reduced significantly.

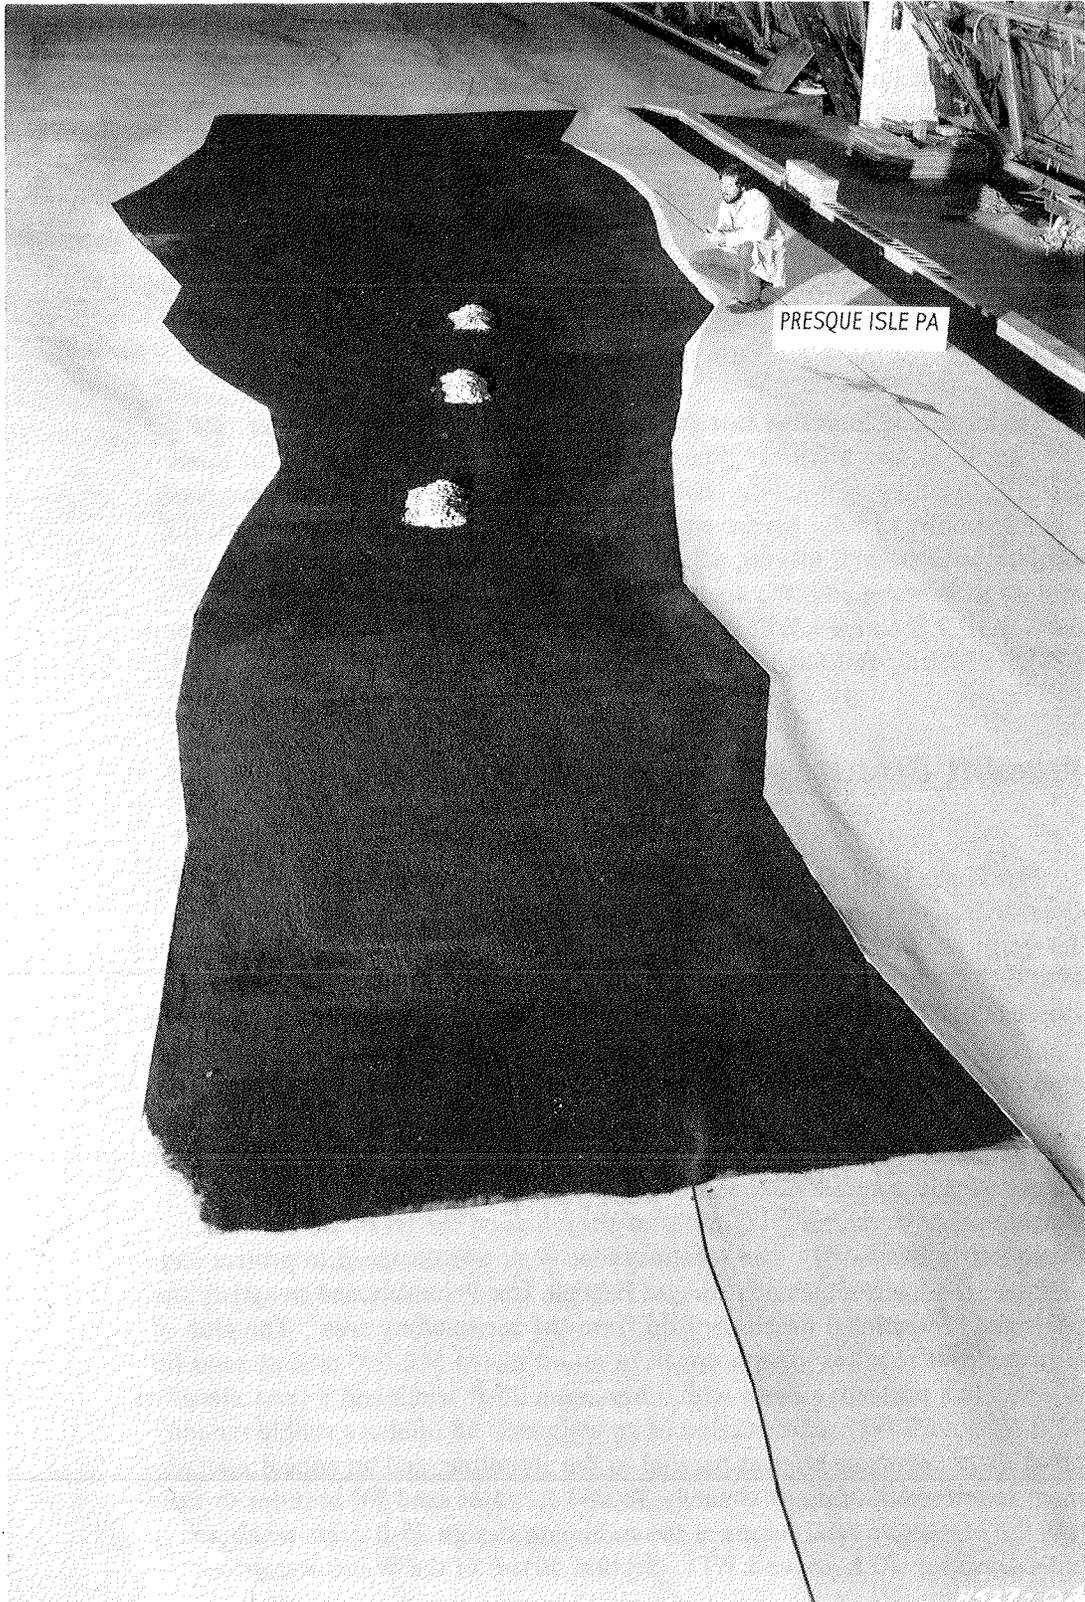
Figure 40. Moveable-bed model of Beach No. 10 (Seabergh 1983)

Model testing indicated that the crown elevation of the breakwater relative to water level was a critical factor in determining whether a salient or tombolo formed. Tombolo formation occurred under the lower wave and water level test conditions. Under severe wave and high water level test conditions, the tombolo was eroded, leaving a salient. Since tombolo development was not desired at Presque Isle, the crest elevation of the breakwaters was reduced from +10.2 ft above LWD as proposed in the Phase I GDM to +8.0 ft above LWD (USAED, Buffalo 1986).

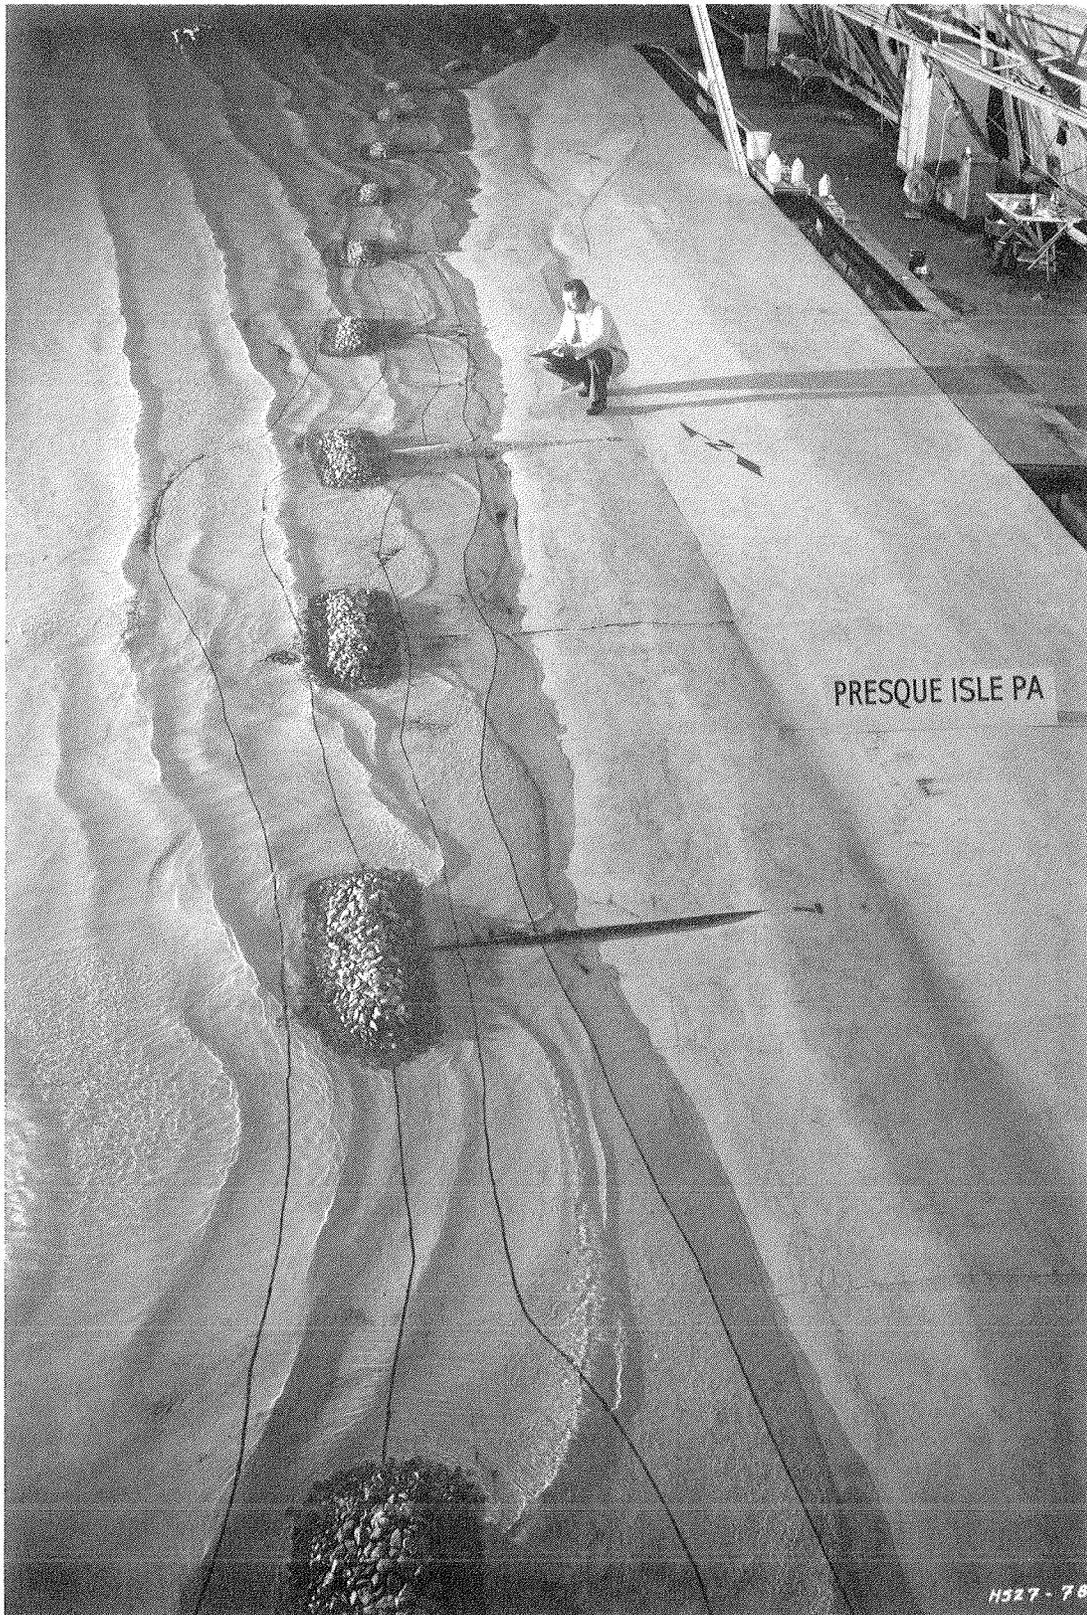
Figure 41. Present authorized plan in physical model (Seabergh 1983)

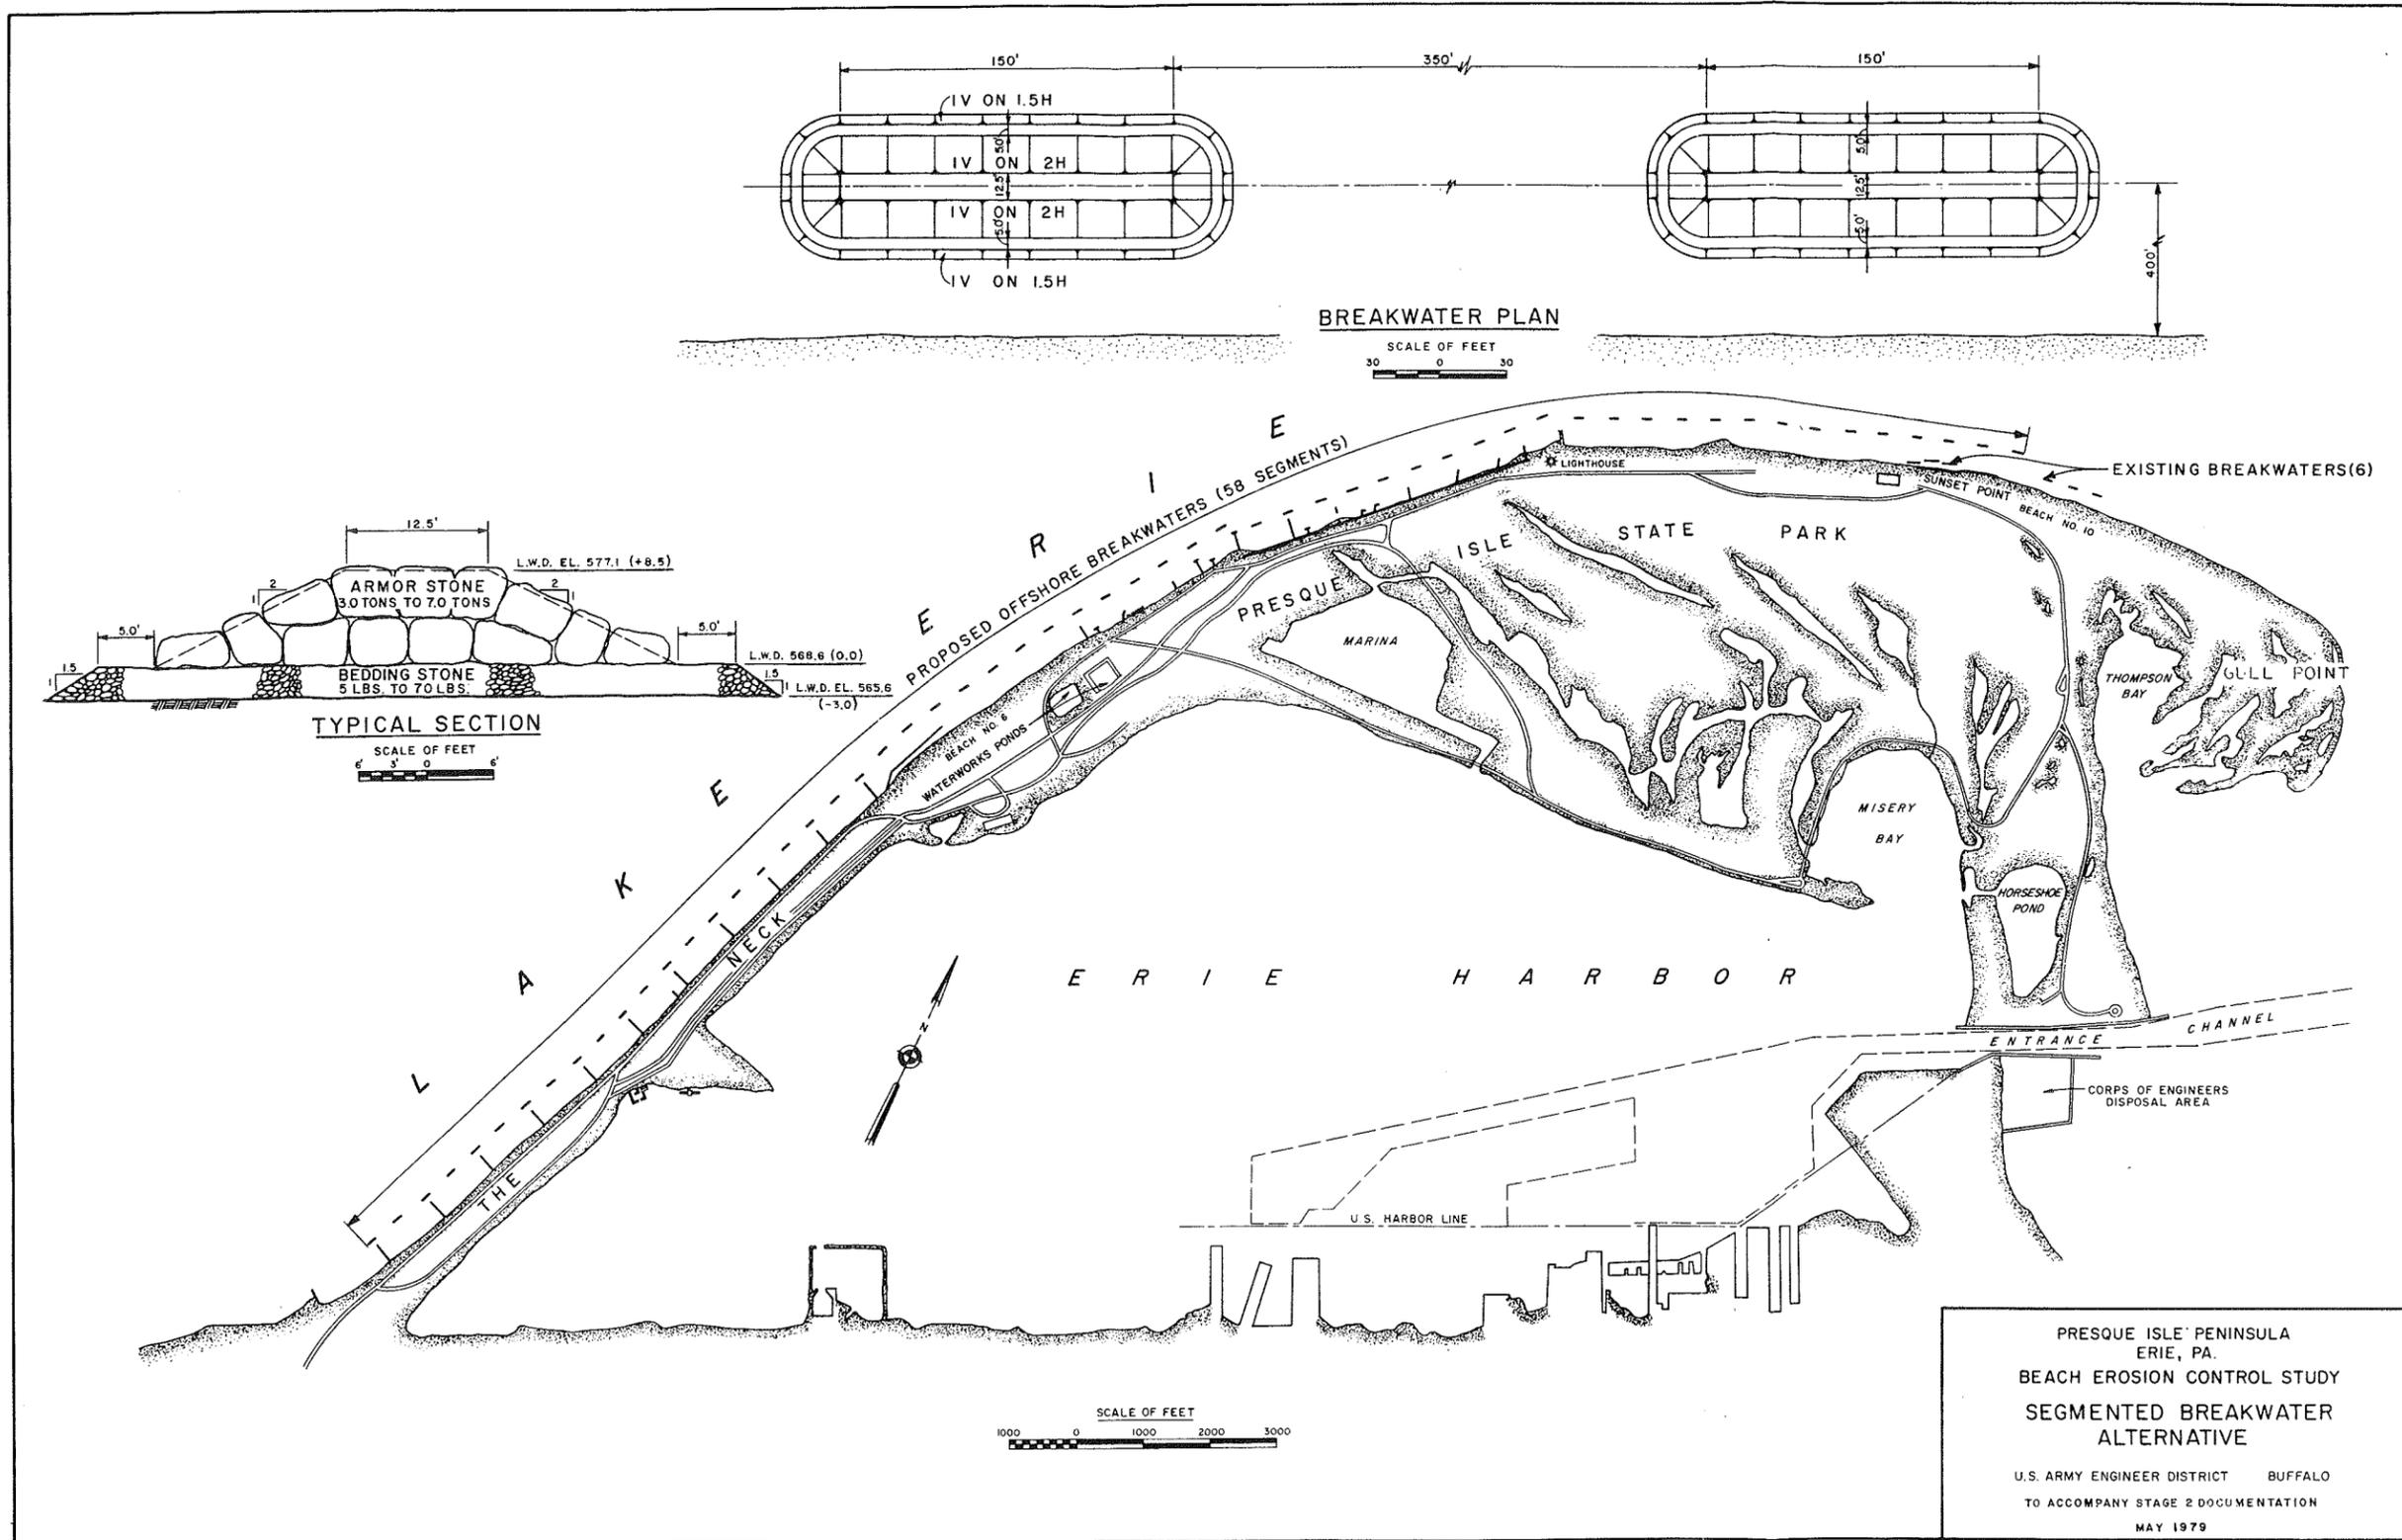
PLATE 10

Figure 42. Present authorized plan of erosion control structures at Presque Isle (modified from USAED, Buffalo (1986))

The plan of improvement recommended in the Phase II GDM is shown in Figure 42 and consists of constructing structures for wave attenuation and beach restoration along 5-1/2 miles of shoreline on the lakeward side of Presque Isle Peninsula. The recommended plan was designed to protect and maintain the environmentally unique Presque Isle Peninsula and to satisfy the projected recreational beach demand from the surrounding area. The plan of improvement requires the placement of an estimated 560,000 tons of sand fill to provide a protective berm with a minimum 75-ft width and a crest elevation 10.0 ft above LWD; construction of an estimated 58 offshore rubble-mound breakwater segments aligned parallel to the shoreline; and an annual nourishment requirement of approximately 38,000 cu yd of sand fill in order to maintain the protective sand berms at the minimum design 75-ft crest width and a crest elevation 10 ft above LWD. Section 501(a) of the Water Resources

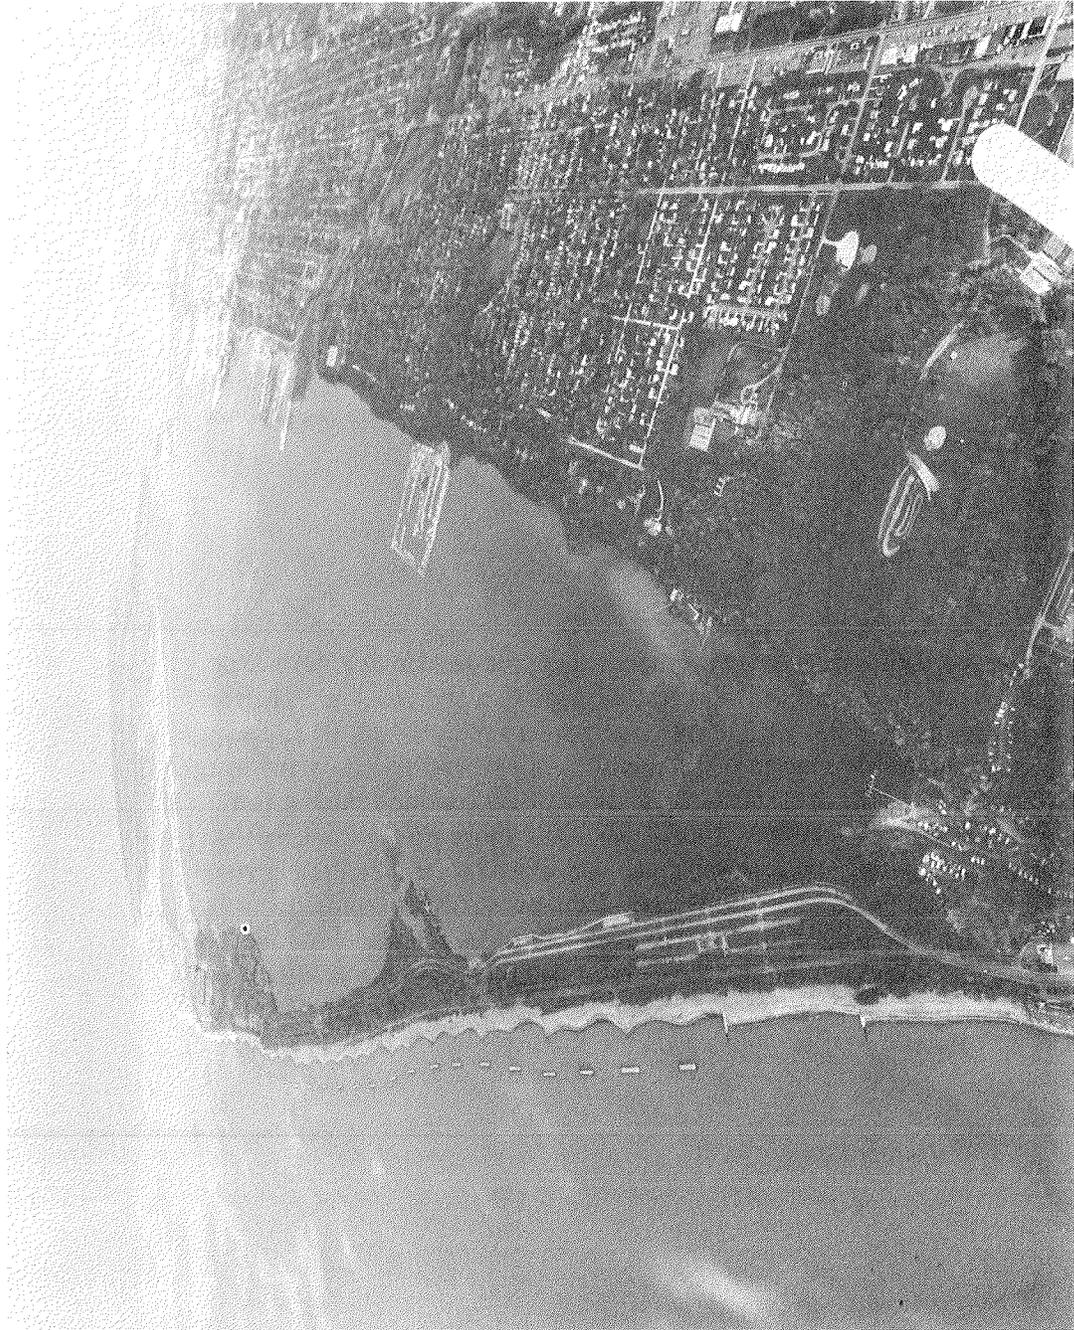
Figure 43. Completed breakwater project at Presque Isle, PA, Fall 1992
